# ROTARY FUNDED SAND DAMS

LEKURRUKI, KENYA

This report details the successful completion of this Rotary-funded sand dam in northern Kenya, Lekurruki Conservancy, Laikipia County.

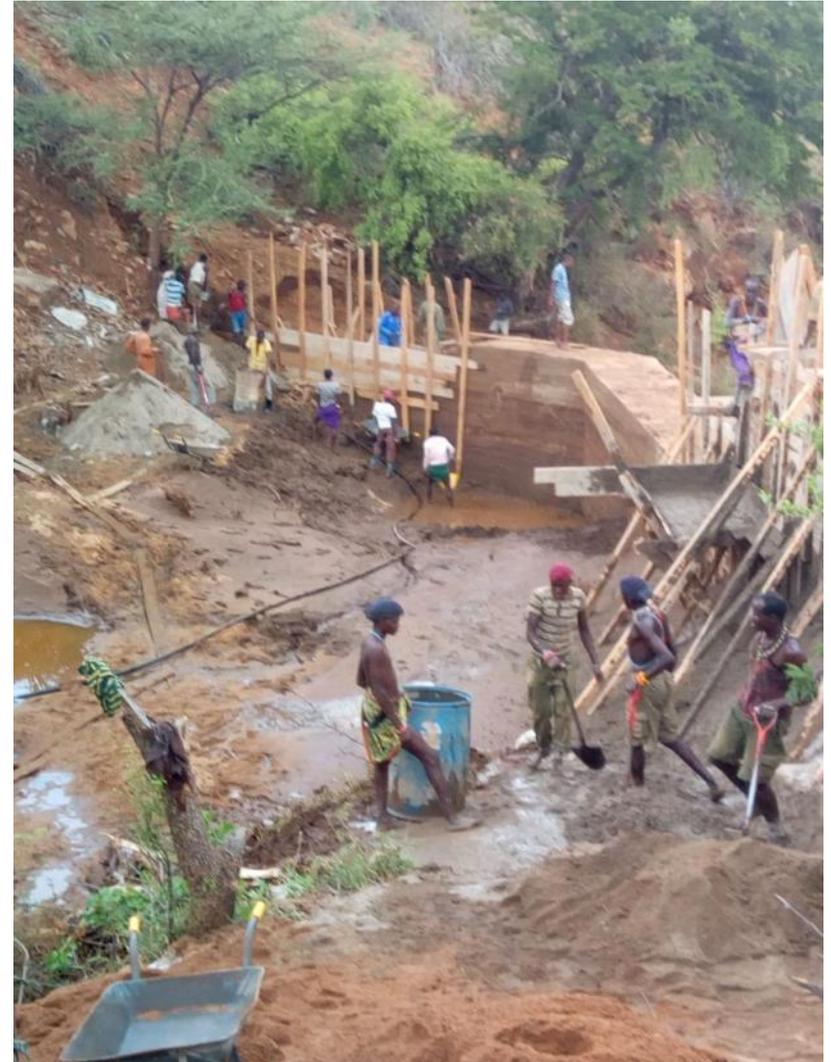
Tassia A dam under construction

The day after construction is completed, the timber shuttering is removed. Barbed wire used to reinforce the structure is trimmed and any holes or exposed rocks are plastered with mortar. Finally, in order for the dam to reach its maximum strength and to prevent shrinking and cracking, the dam is watered to 'cure the cement' for 4 weeks after construction. Keeping the dam hydrated in this way lets the cement and sand particles bond together.

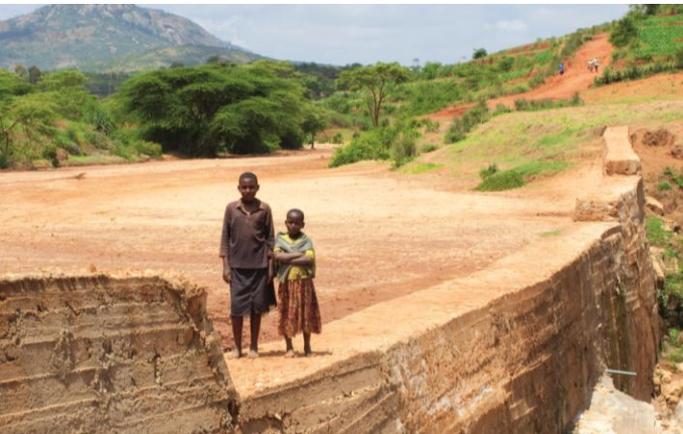
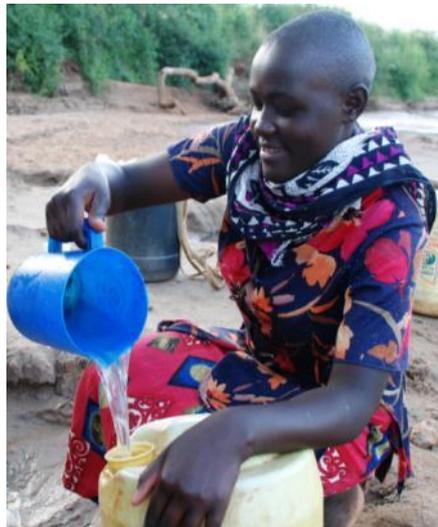
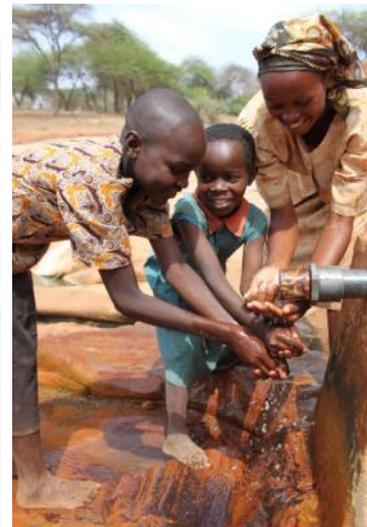
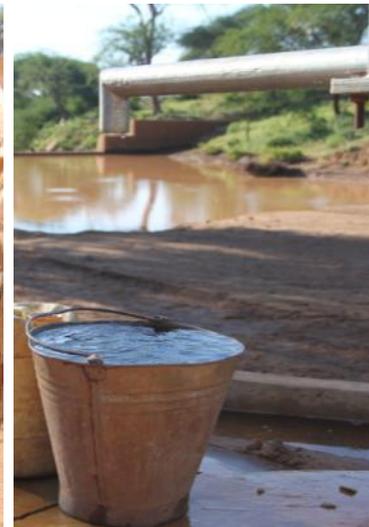
1. People use traditional scoop holes to collect water from any point along the dam.
2. Infiltration galleries leading to pipes or taps enable water to be abstracted through the dam wall.
3. Infiltration galleries can also be linked to sealed shallow wells with hand pumps.

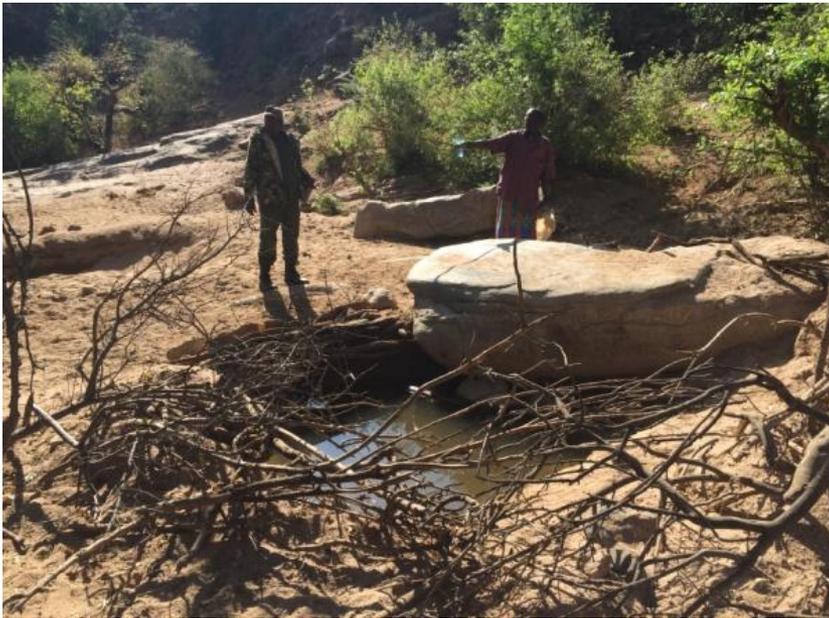
We were told that one of the scoop holes which was full of water (*below left*), was in a place where water had not been present since the river stopped flowing some years ago. There were other areas of greenery and the area was damp behind the dam, adding weight to the hope that a series of dams along this river will result in the Tassia River flowing permanently again, and transform this area for people, livestock, and wildlife.

Thanks to Rotary Club support, Lekurruki Conservancy were able to complete their sand dam in March 2018. Following some very significant rainfall, the dam is now full of sand, and holding substantial quantities of water. There are also freshly dug scoop holes on the river downstream with fresh wildlife tracks and evidence of donkeys carrying water, demonstrating both people and wildlife are accessing the water.

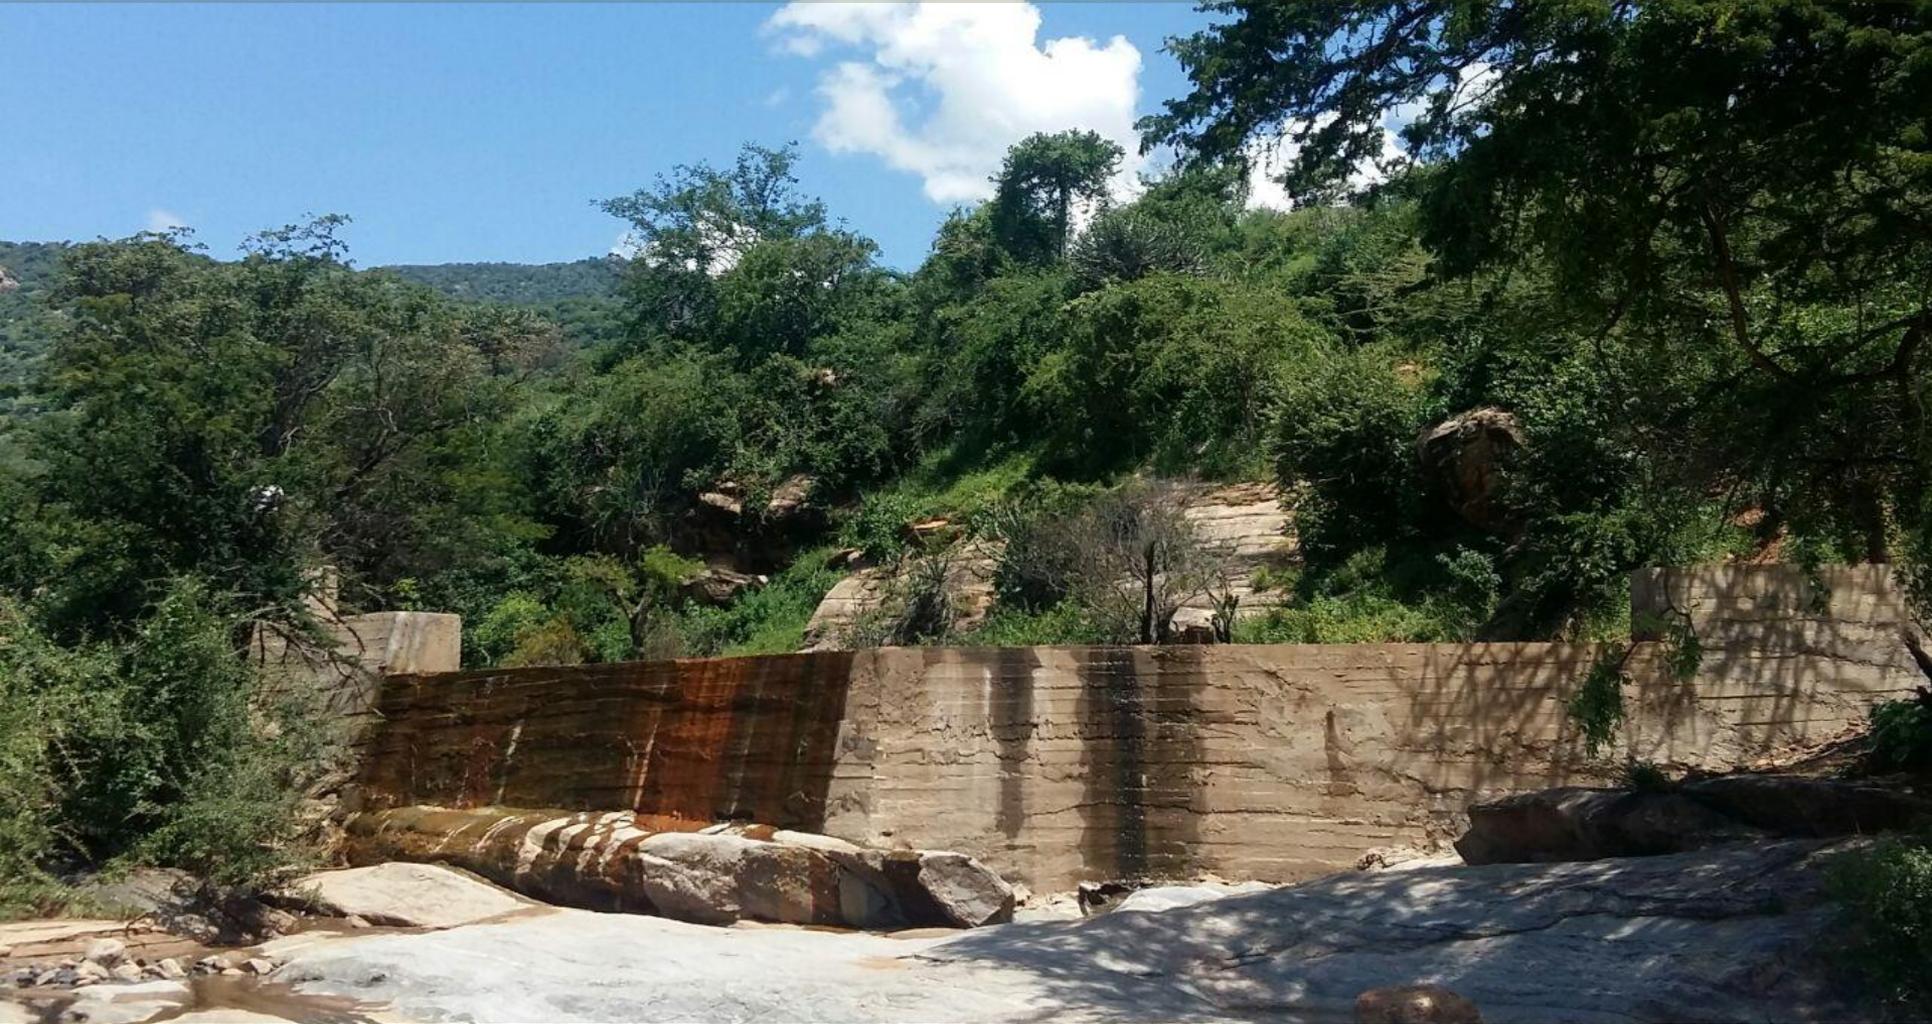
Above: Completed Tassia A dam
